OCCURRANCES OF AMBER STREAK & BUBBLES IN FLINT GLASS

————— *A CASE STUDY* —————

AN APPROACH TO RESOLVE AMBER STREAK AND BUBBLES IN GLASS BOTTLES

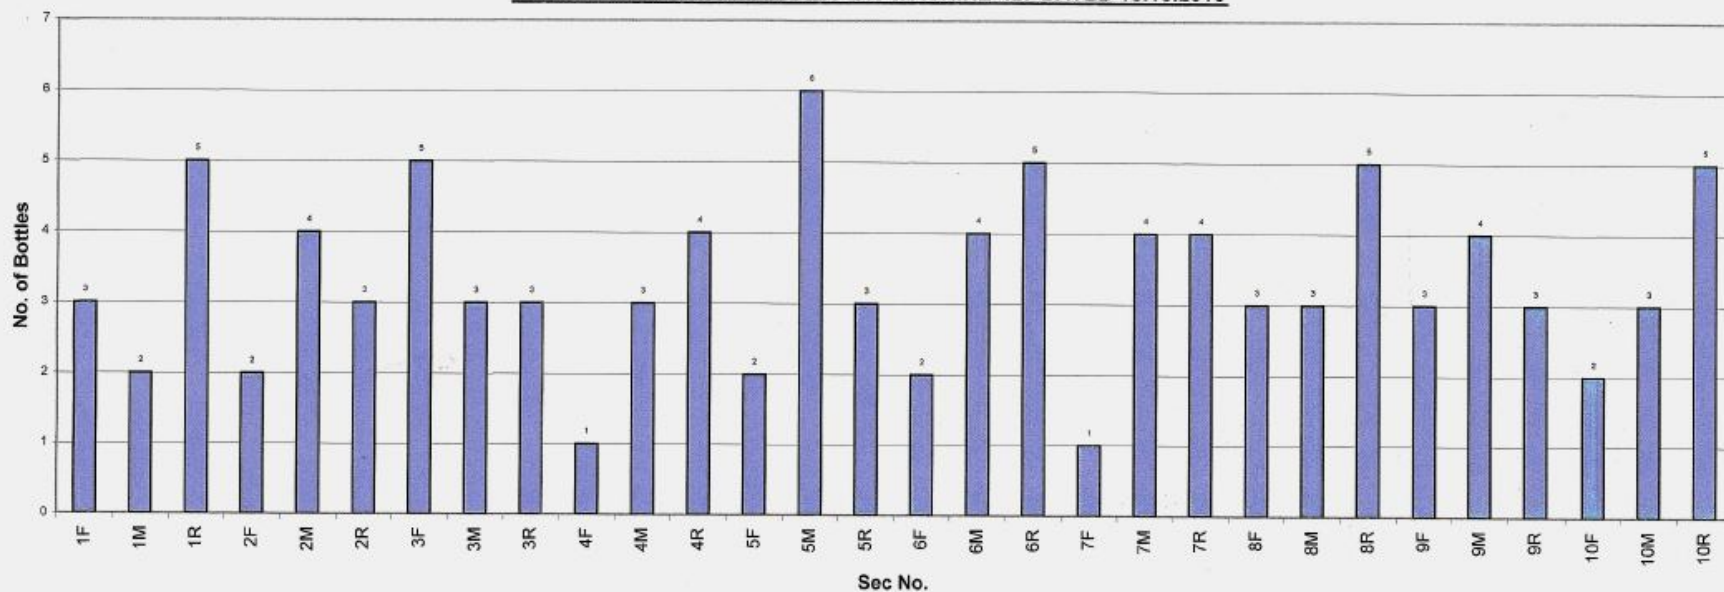
AMBER STREAK IN 200ML MAAZA ON MACHINE:27

YELLOW LINE IN 200 ml MAAZA ON MACHINE :27 DATED 18.10.2010

Having assumed some foreign material was lying inside the fore-hearth no:27, at first, we did heavy draining of glass of that particular fore-hearth several times: though it offered a temporary relief but problem resumed soon afterwards.

We therefore provided a cooling arrangement at the bottom of the working end and close to the line 27 connection block on 27.10.2010. The size of the wind box was 2150mm(length)x850mm(width)x330mm depth extending equally on either side of the fore- hearth 27. Subsequent to this, we had noticed considerable reduction of almost 95% Amber streaks, and we were continuing the same cooling arrangement. However, we did keep noticing Amber streaks on the adjacent lines periodically for about one hour or two hours once in two days or so.

On 18.11.2010 we started throat boosting on continuous basis. After few days Amber streak problem gradually disappeared.

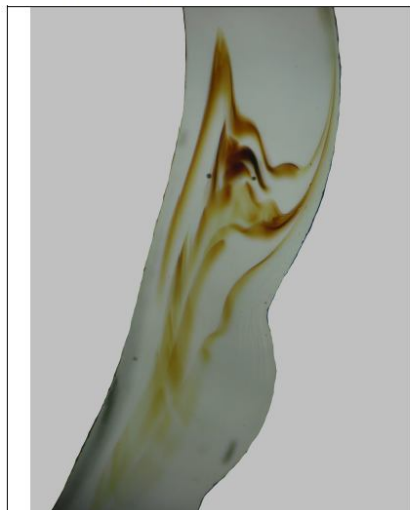
The defect from Sample Amber streak – Body in polished cross-section under stereomicroscope

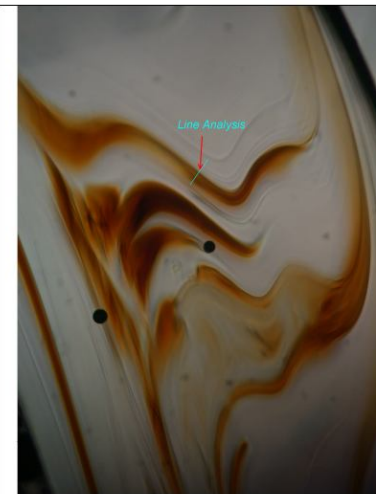
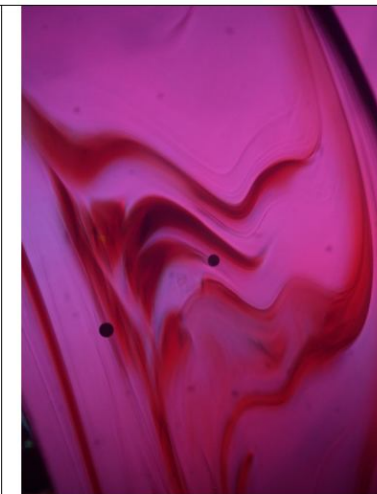
The defect from the Sample Amber streak Body in polished cut in passing through light and in passing through polarized light between crosses polars with interference wafer of the first order

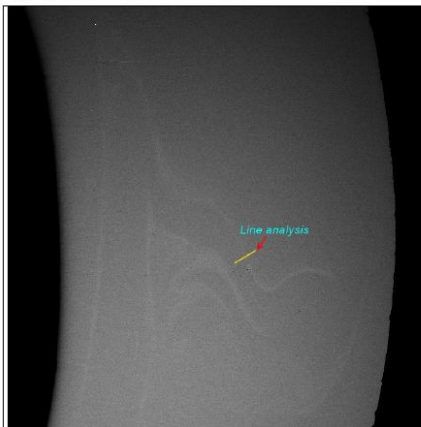
The defect from the Sample „Amber streak Body“ in polished cut under electron microscope – BSE detector

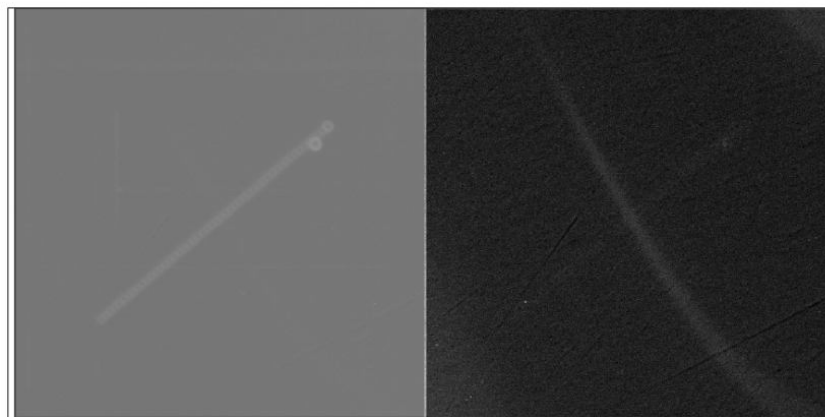
The analyzed part of the defect from the Sample „Amber streak Body“ in polished cut under electron microscope – SE and BSE detector – with traces originating from line analyses

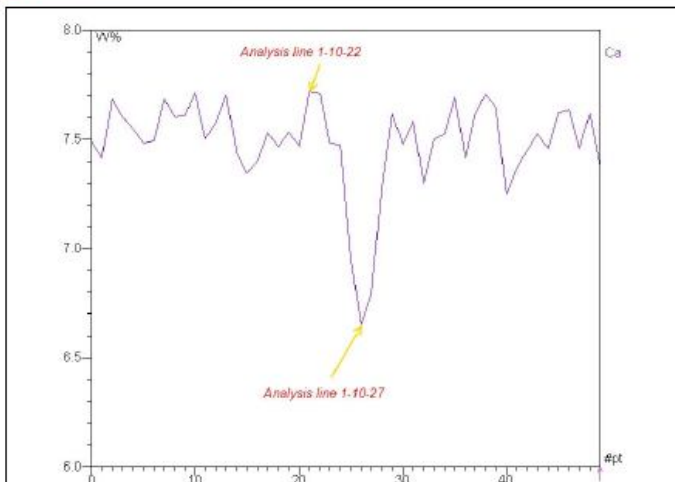
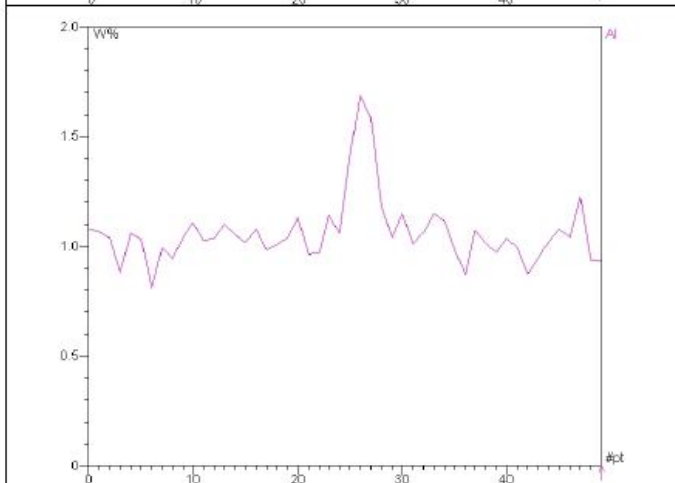
Results of presence of Ca and of Al in marked area from the Sample Amber streak Body

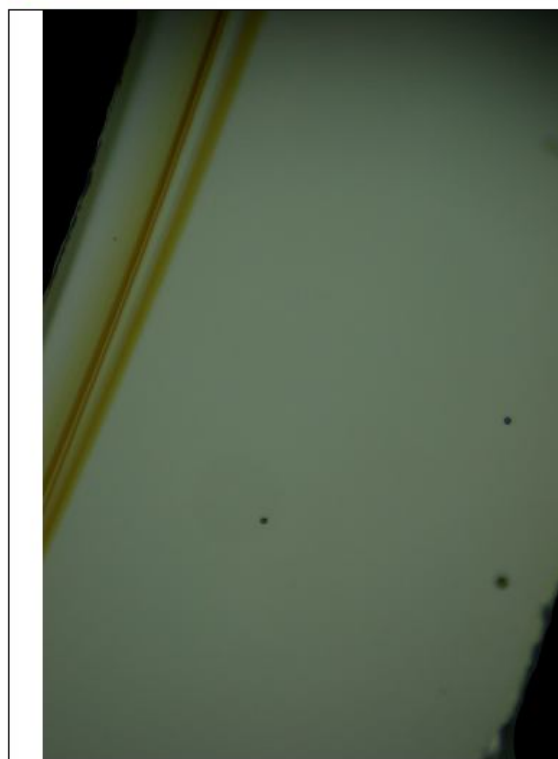
The defect from the Sample „ Amber streak Bottom “ in polished cross section in passing through light

The flowing of corrosion products from Aluminosilicate/Alumina refractory caused the rise of this defect.

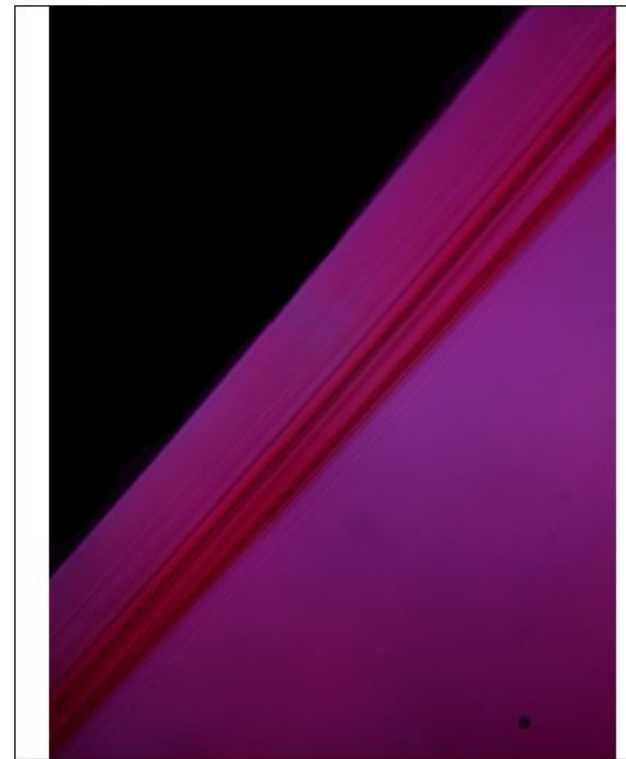
The detail of the defect from the Sample „ Amber streak Bottom “ in polished cut in passing through polarized light between crosses polars with interference wafer of the first order

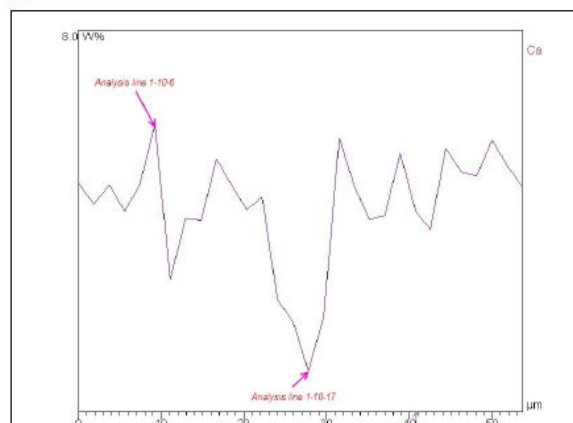
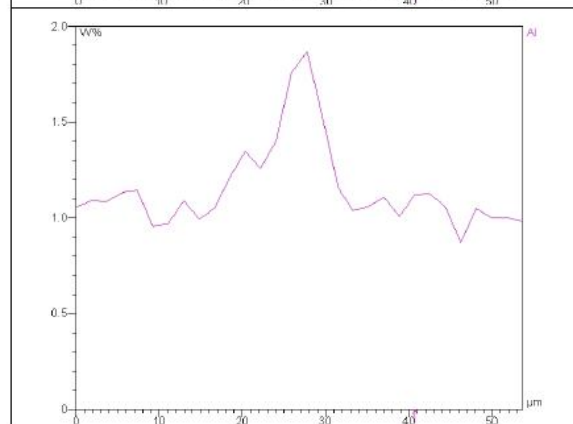
Results of Ca presence and of Al presence in marked area from the Sample Amber streak Bottom

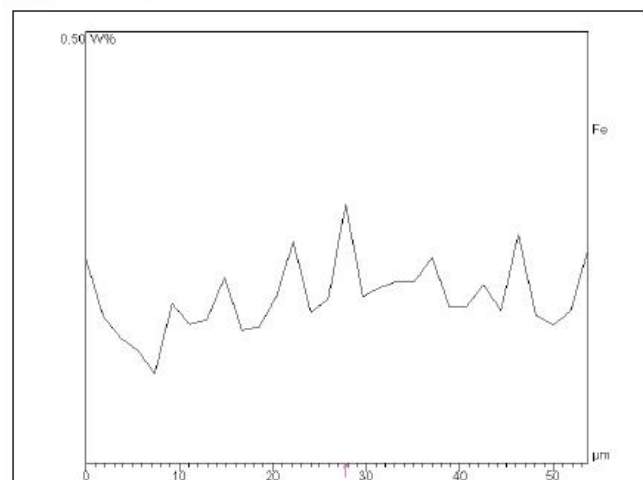
Results of Fe presence in marked area from the Sample „ Amber streak Bottom “

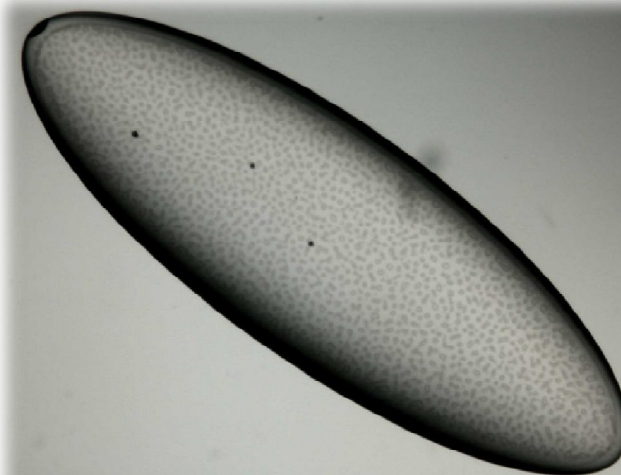
The Deposits inside the bubble in passing through light

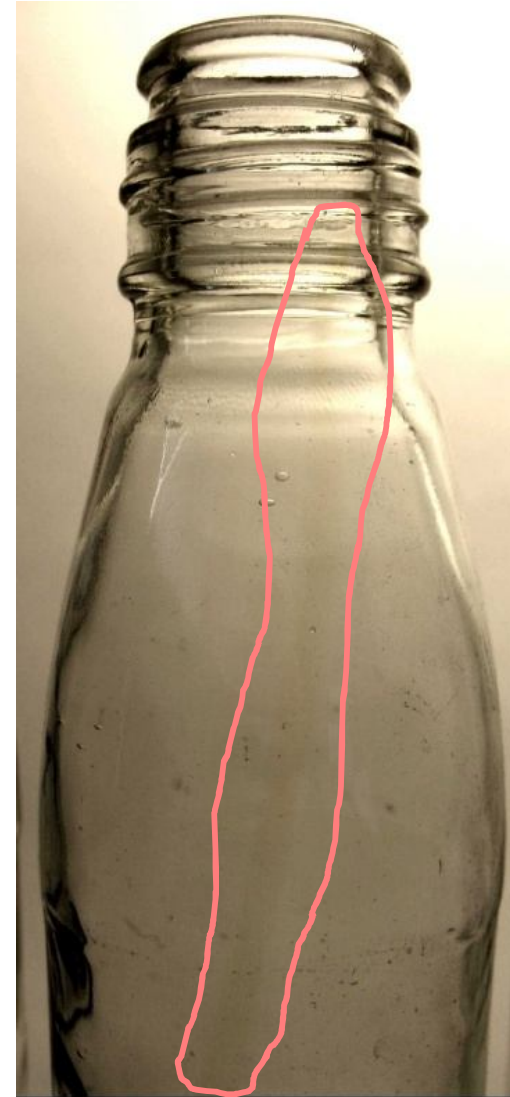
Amber streak bottle

There was observed a distinct amber streak in the Bottle. There should be a possibility of the bubble appearance due to potential melting issues as namely temperature variations and/or pull change, initiating the release of the dead zones containing the stagnant glass having the different redox state.

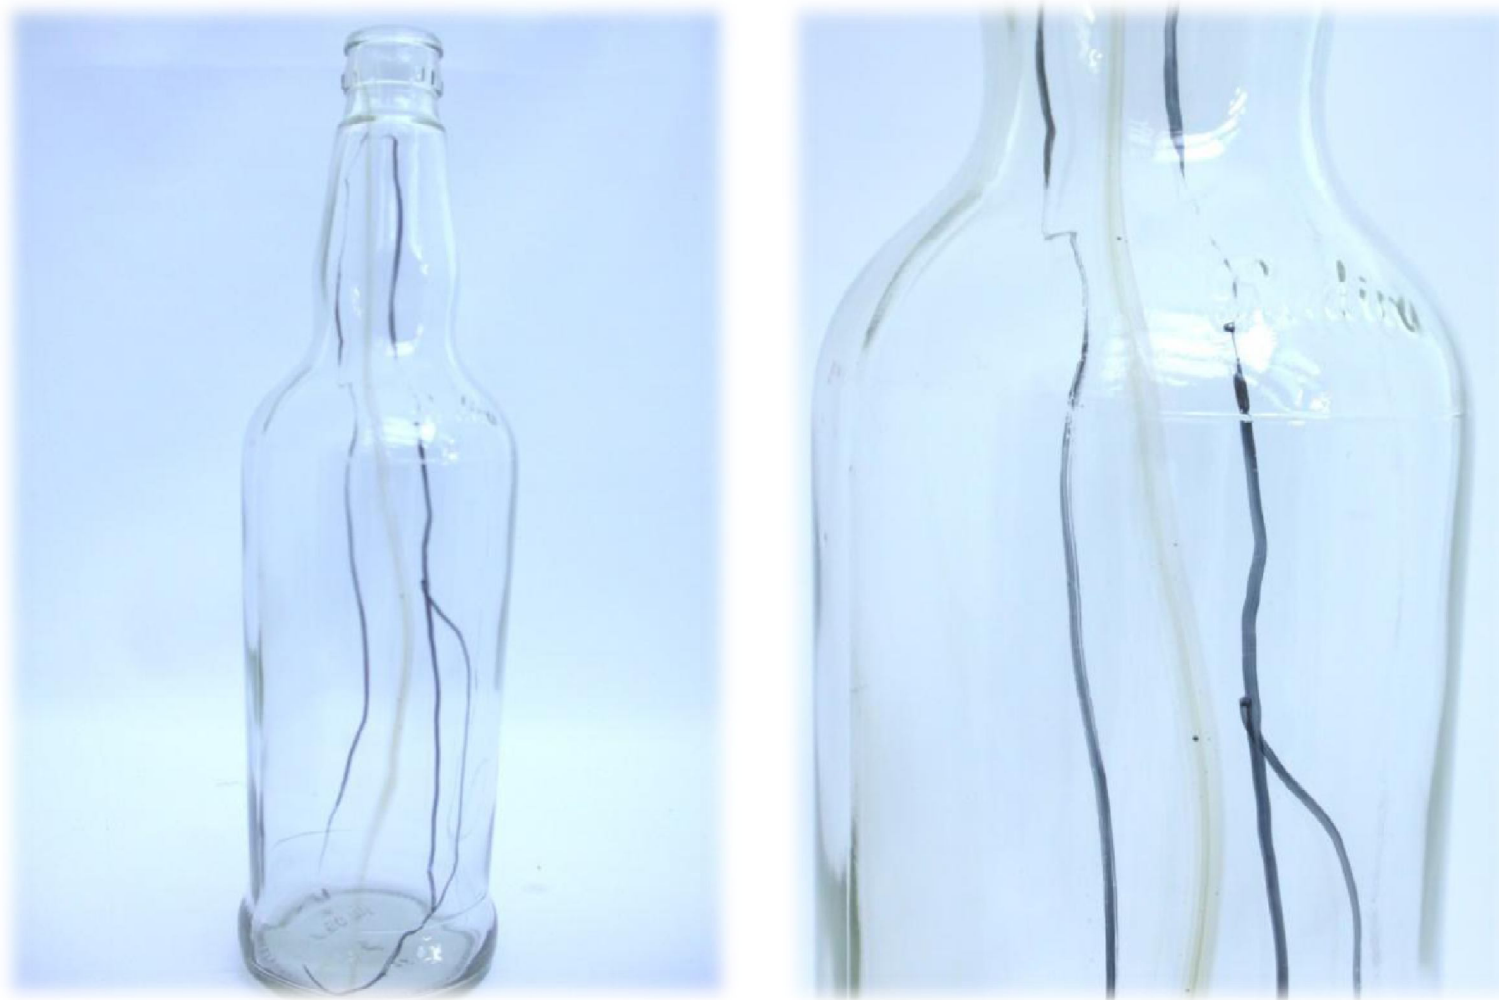
Photographic recording of the glass bottle with amber stripes. The right figure shows two of the larger inclusions are highlighted.

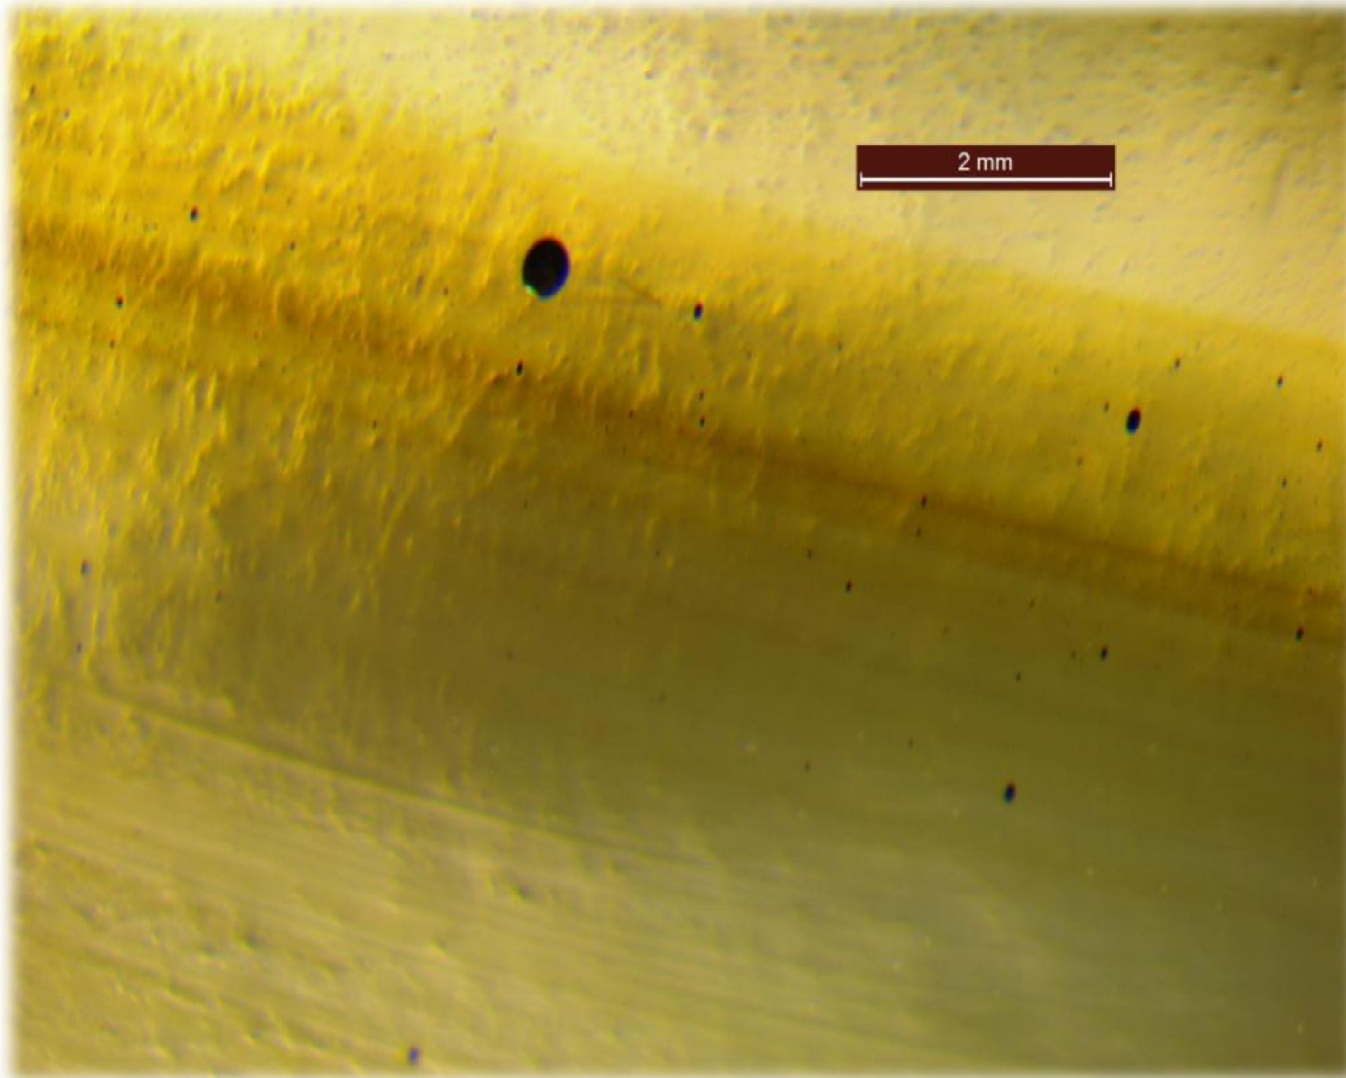
Micrograph of inclusions

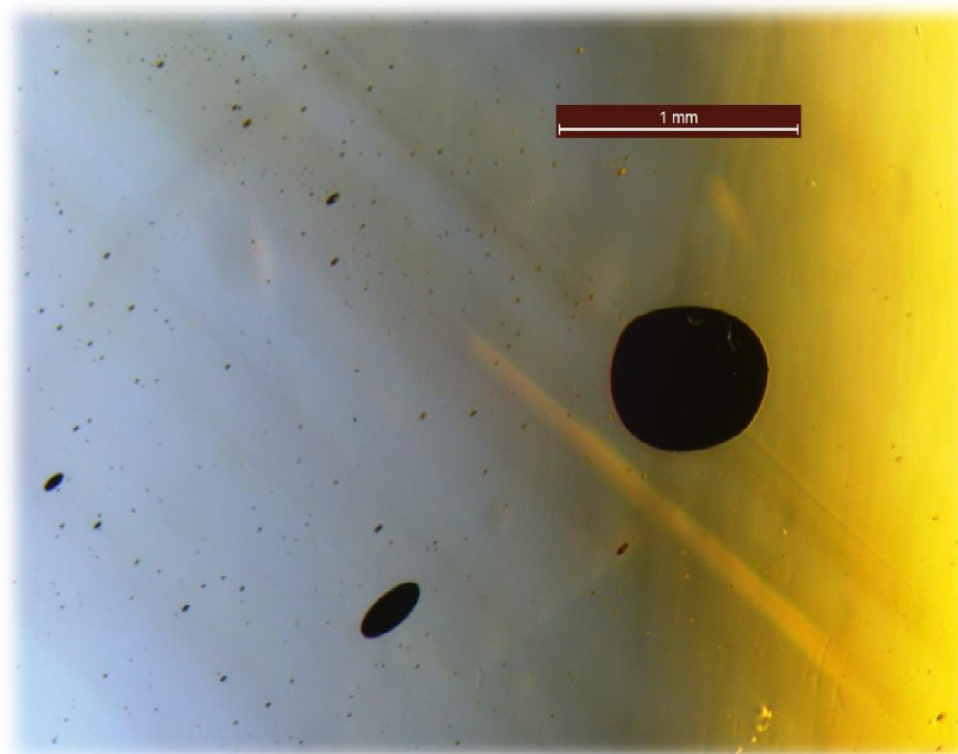
Further Detail of black inclusions.

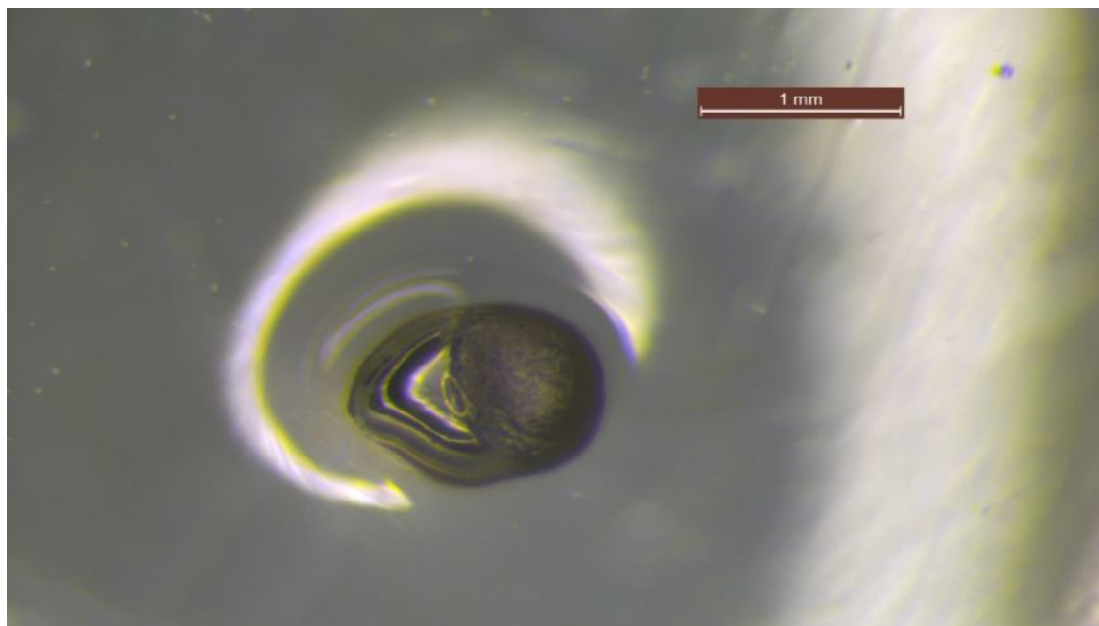
Micrograph of black inclusion

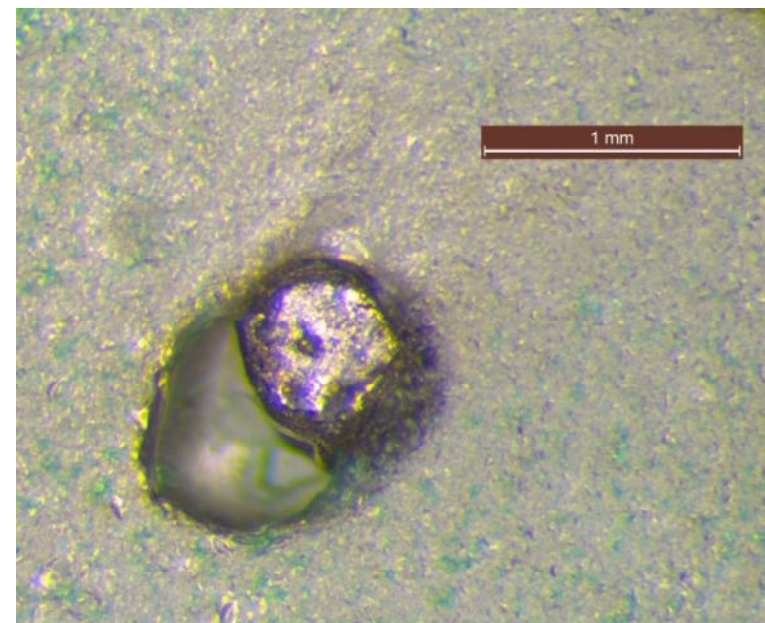
The inclusion has been sanded. The included foreign body is shining metallic. With LIBS, a high content of iron and manganese could be detected at this point. It also the elements copper, vanadium, molybdenum, and chromium are found.

Micrograph of sanded foreign body
