OCCURRANCES OF AMBER STREAK & BUBBLES IN FLINT GLASS

————— *A CASE STUDY* —————

AN APPROACH TO RESOLVE AMBER STREAK AND BUBBLES IN GLASS BOTTLES

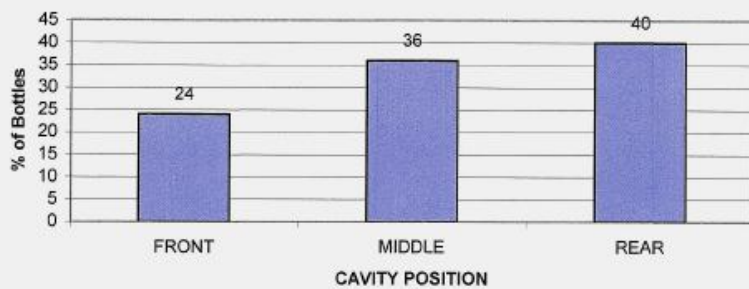
AMBER STREAK IN 200ML MAAZA ON MACHINE:27

% of Yellow lines on 85 TG 10F MACHINE

Having assumed some foreign material was lying inside the fore-hearth no:27, at first, we did heavy draining of glass of that particular fore-hearth several times: though it offered a temporary relief but problem resumed soon afterwards.

On 18.11.2010 we started throat boosting on continuous basis. After few days Amber streak problem gradually disappeared.

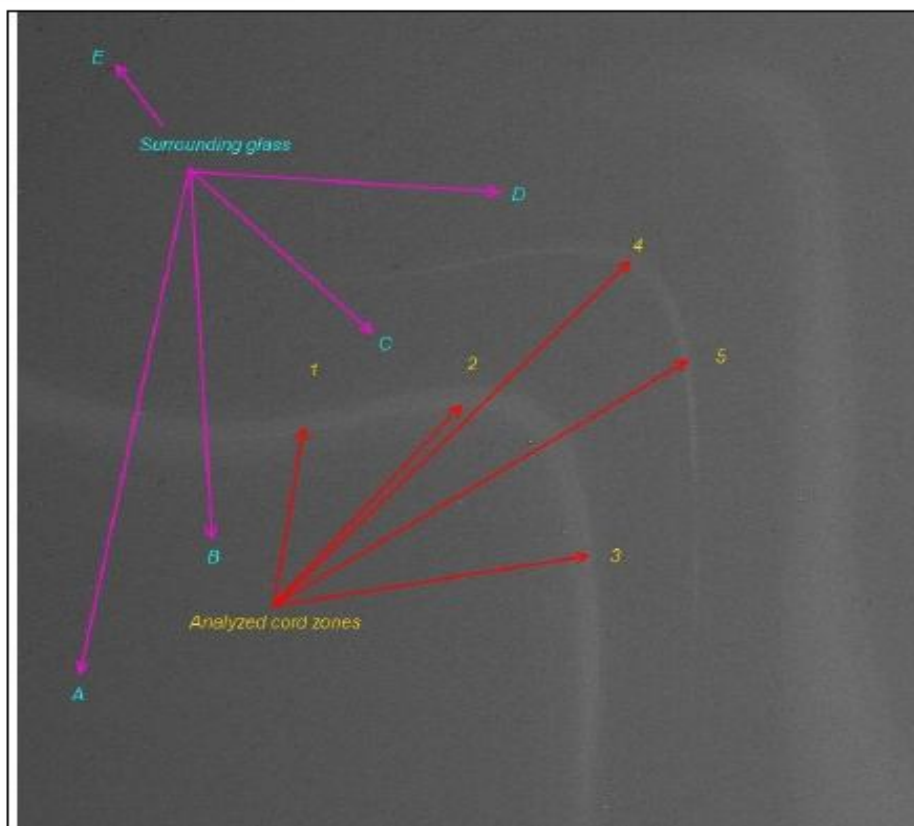
The analyzed part of the defect from the Sample „ Amber streak Body “ in polished cut under electron microscope – BSE detector – with marks of analyzed zones

The explicit account of the presence of this defect in glass is very difficult. Our SEM-EDX microanalysis not given account of the problem of coloration of the defect (amounts of iron and of other possible coloring agents are rather under area of detection limit), nevertheless this colored streak has had increased content of Al_2O_3 with simultaneous decreased content of CaO against the surrounding glass.

The flowing of corrosion products from Aluminosilicate/Alumina refractory caused the rise of this defect.

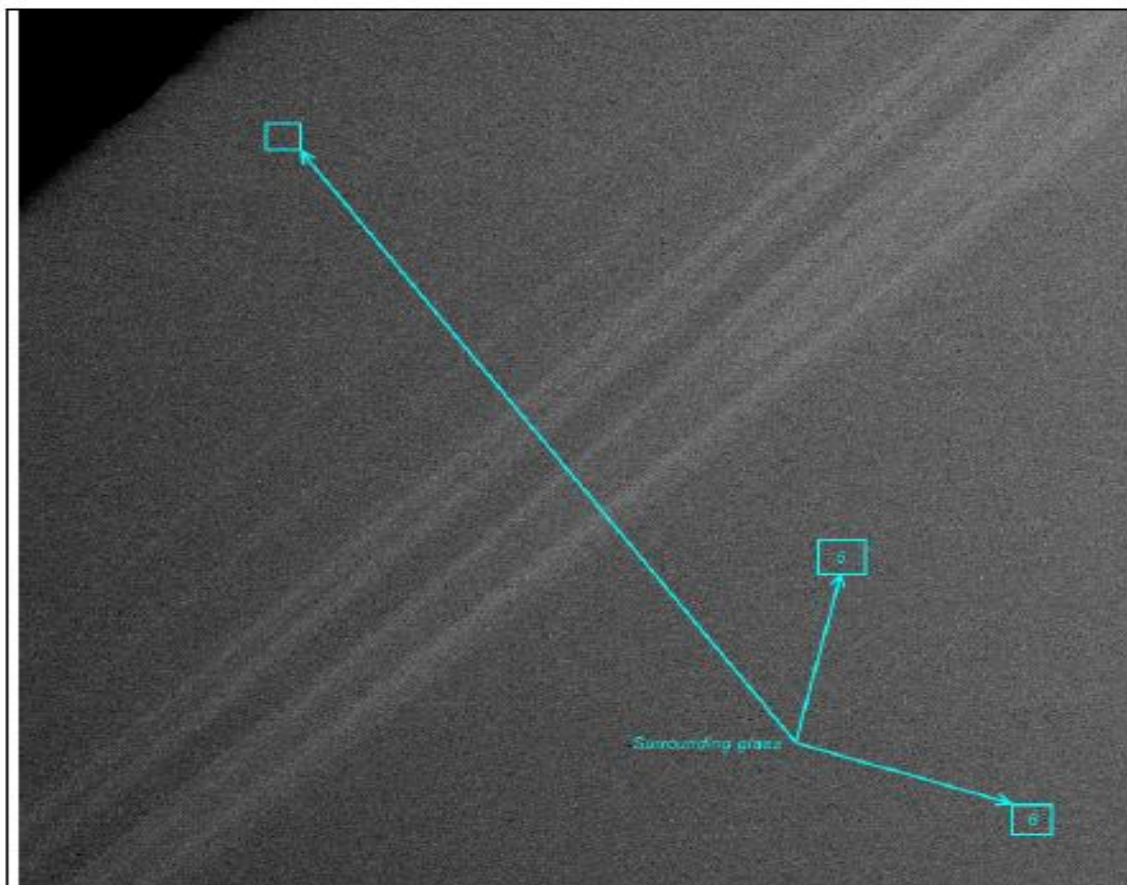
The defect from the Sample „ Amber streak Body “ in polished cut under electron microscope – BSE detector

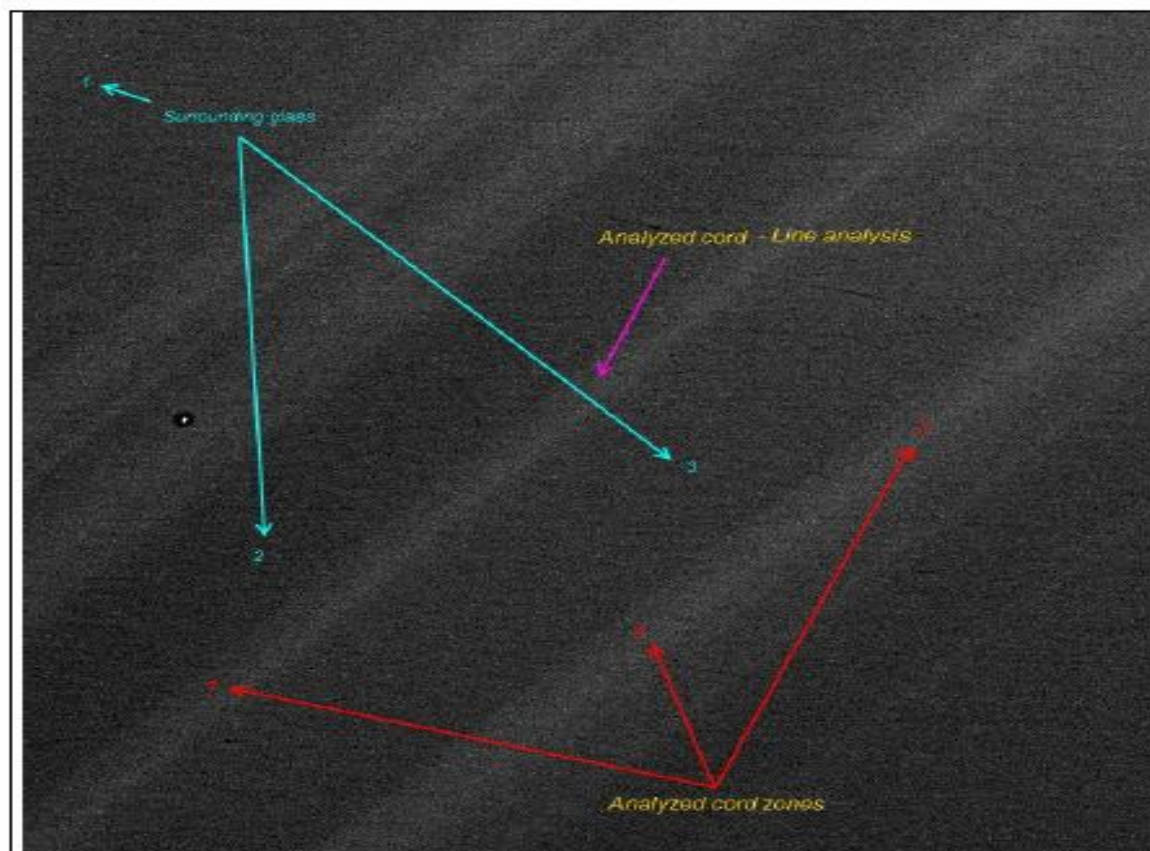
The defect from the Sample „ Amber streak Body “
in polished cut under electron microscope – BSE
detector – with marks of analyzed zones

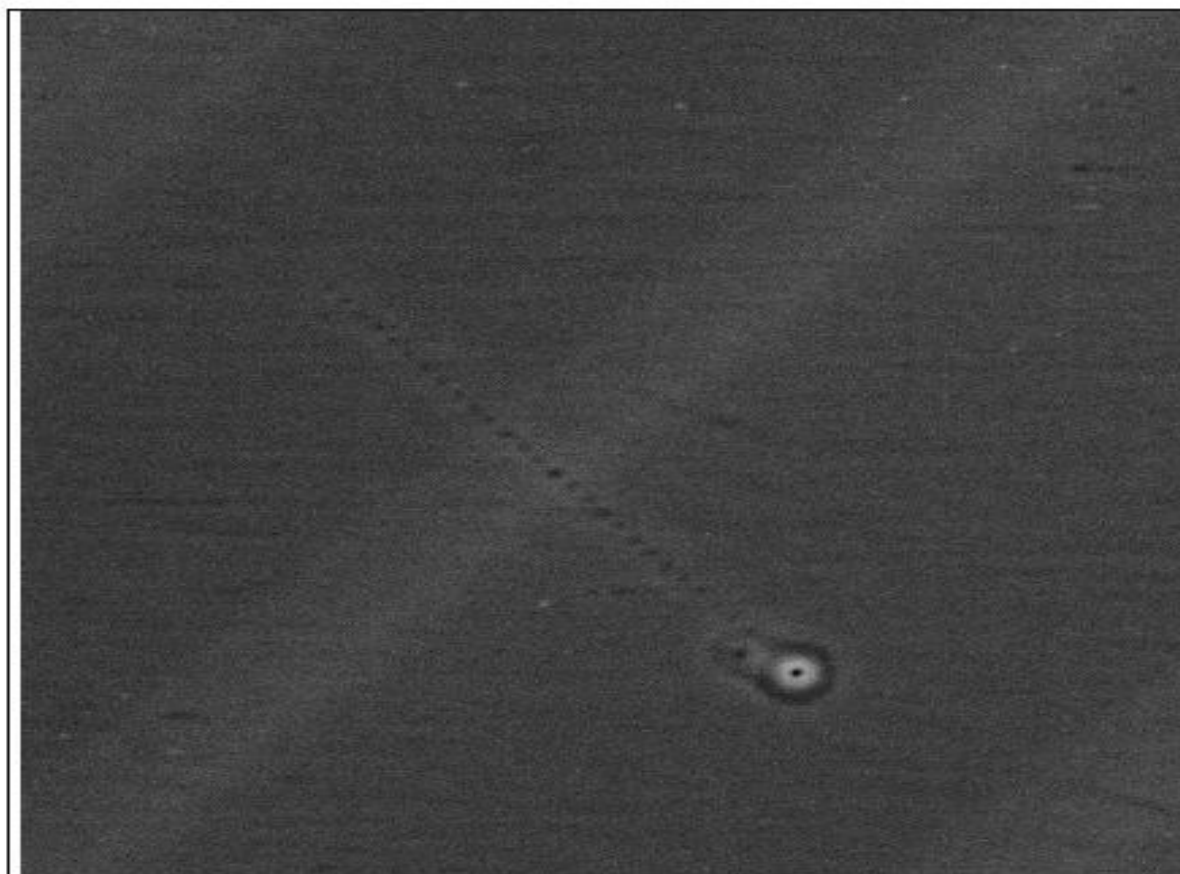
The analyzed part of the defect from the Sample „ Amber streak Body “ in polished cut under electron microscope – BSE detector – with traces originating from line analyses

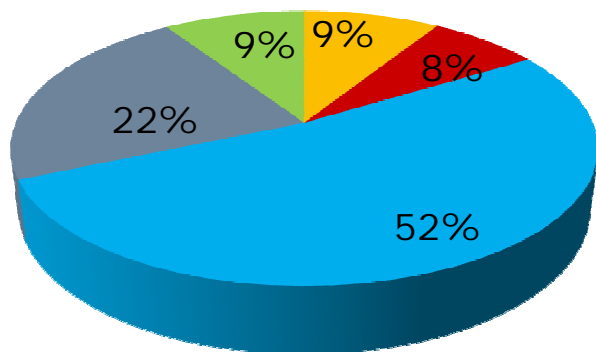
M/C WISE CONTRIBUTION % OF YELLOW LINE

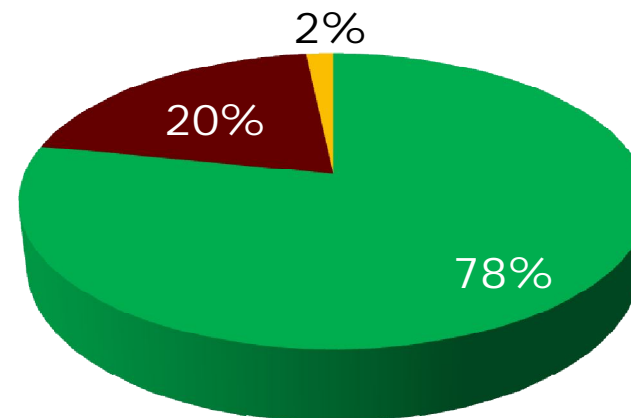
M/C WISE CONTRIBUTION % OF BUBBLES

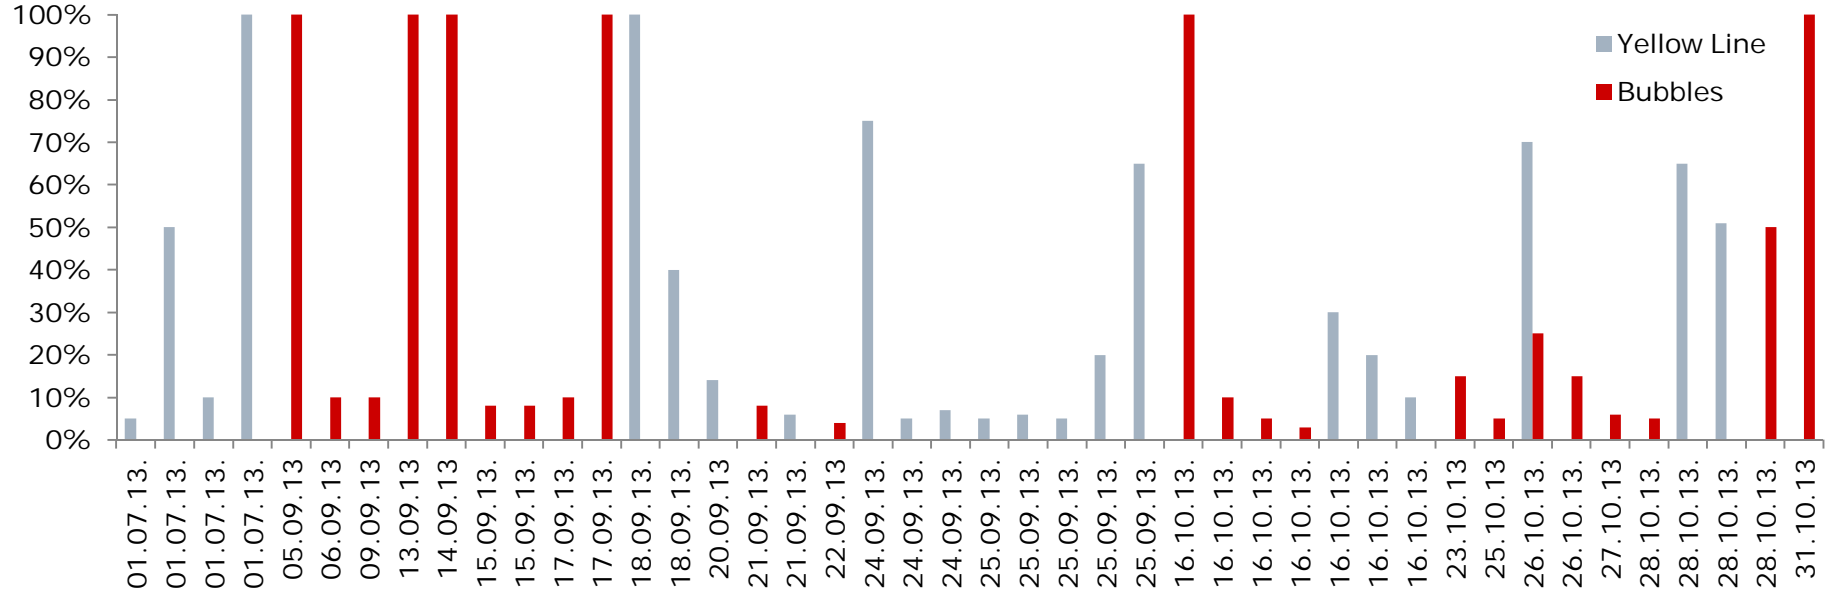
M/C -27 Amber streak Bubbles

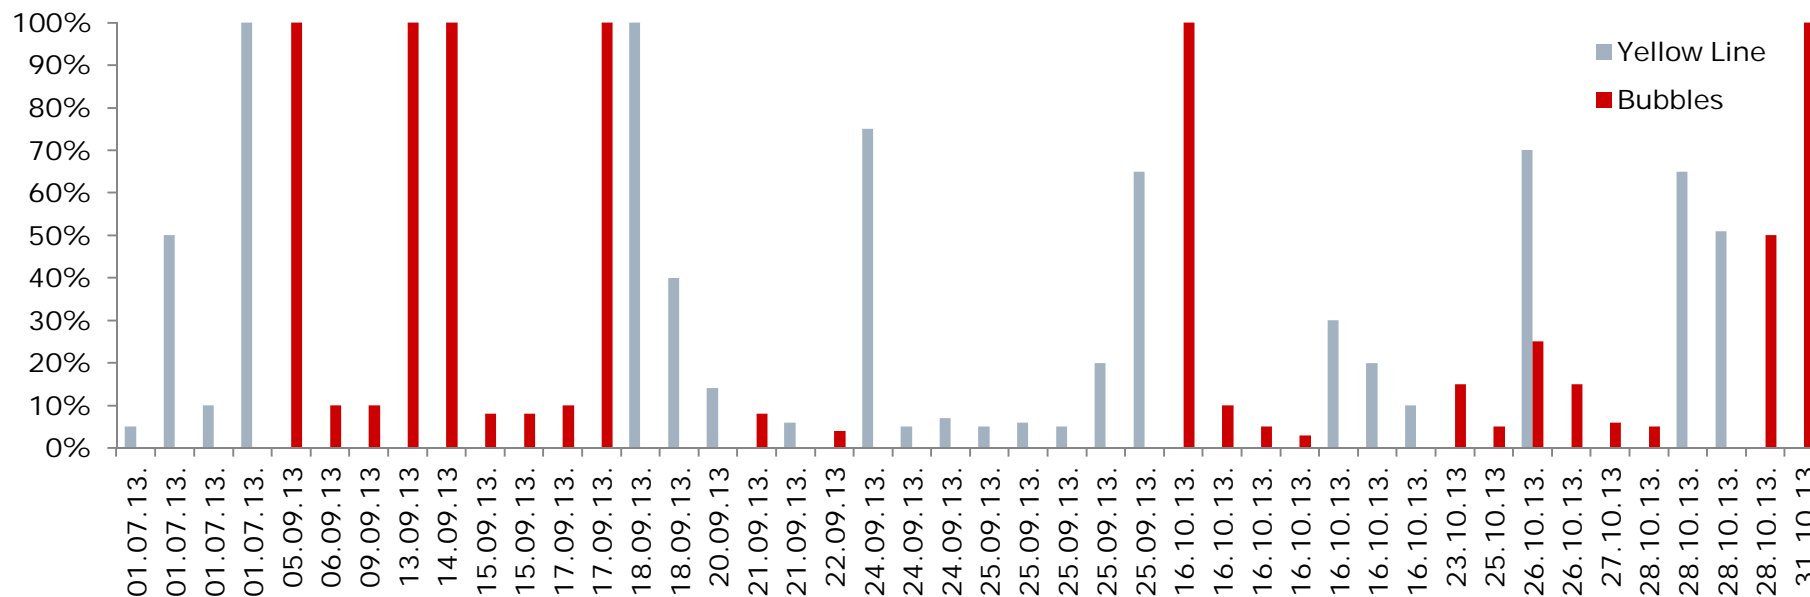
M/C -27 Amber streak and Bubbles

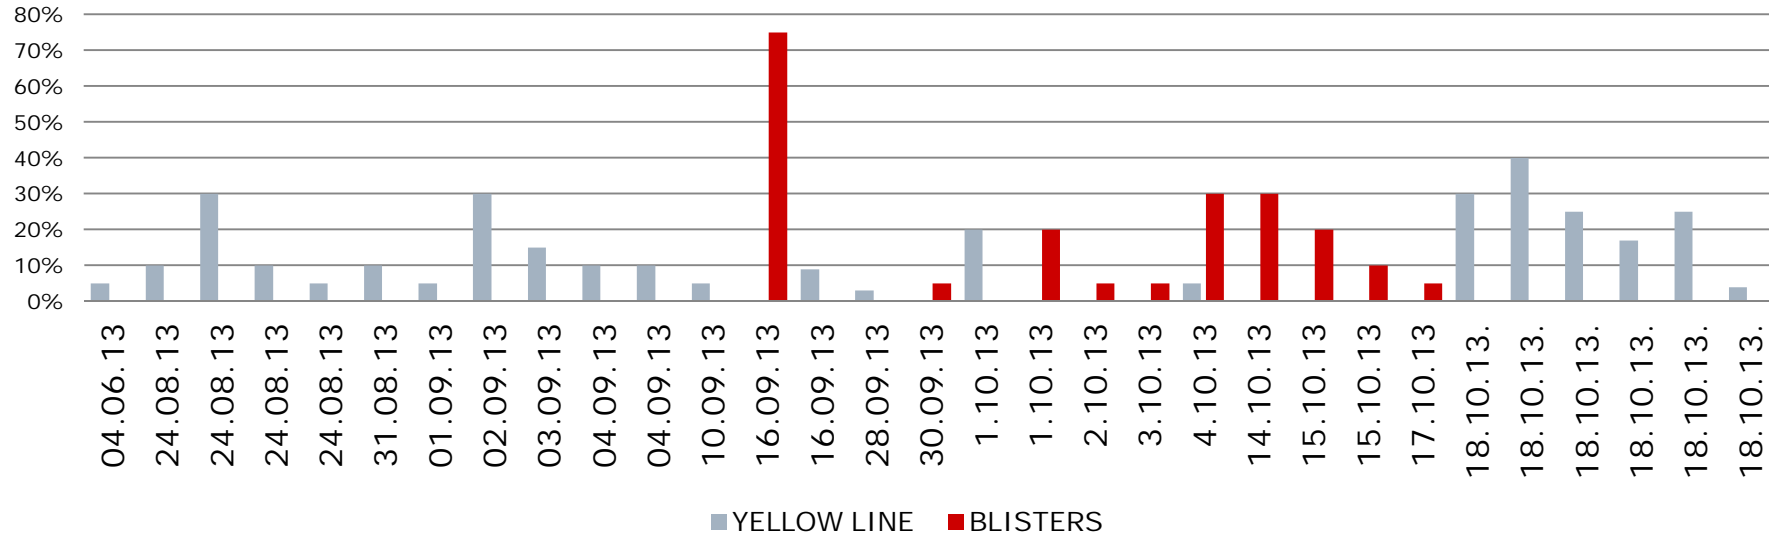
M/C -28Amber streak and Bubbles

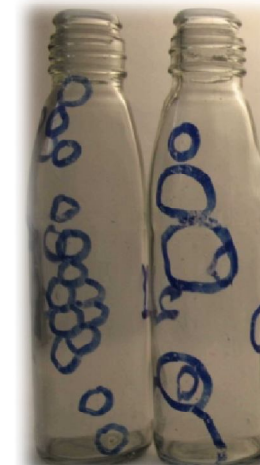
Sample Bottles

There was observed a distinct amber streak in the Bottle. There should be a possibility of the bubble appearance due to potential melting issues as namely temperature variations and/or pull change, initiating the release of the dead zones containing the stagnant glass having the different redox state.

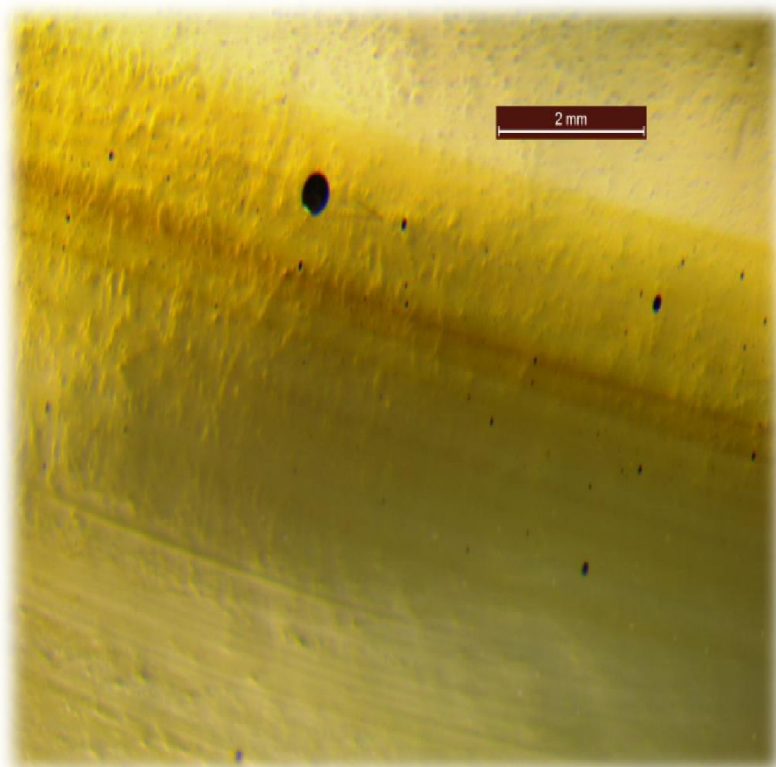
Micrograph of inclusions

The inclusion has been sanded. The included foreign body is shining metallic. With LIBS, a high content of iron and manganese could be detected at this point. It also the elements copper, vanadium, molybdenum, and chromium are found.
